THE PRESERVATION OF HOLT HOUSE: PHASE ONE

Prepared for the Holt
House Preservation Task
Force of the Kalorama
Citizens Association

May 2003

QUINN EVANS | ARCHITECTS
Washington, D.C.

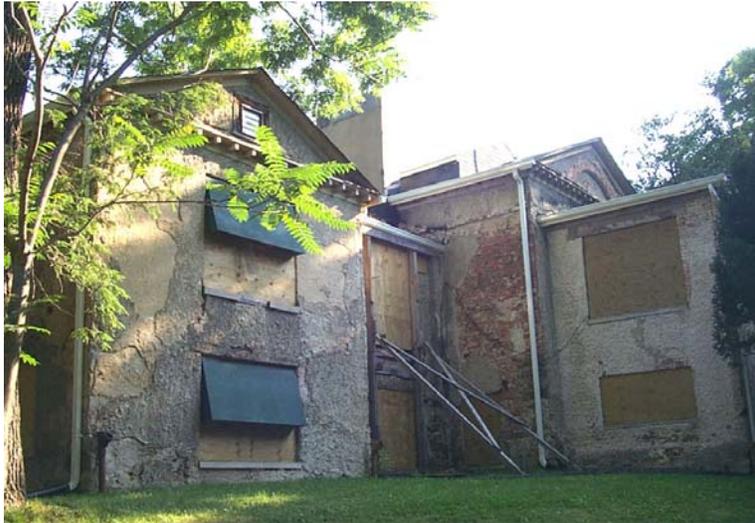
Current Condition - Exterior

The plywood over the windows is to reduce vandalism and eliminate bird and rodent entry. The wooden bracing is shoring a weakened exterior wall. Prior to installation of the roof and the gutter/downspout system, the exterior walls were severely damaged by roof runoff. This caused the stucco to delaminate. The bare brick is now unprotected from the weather.

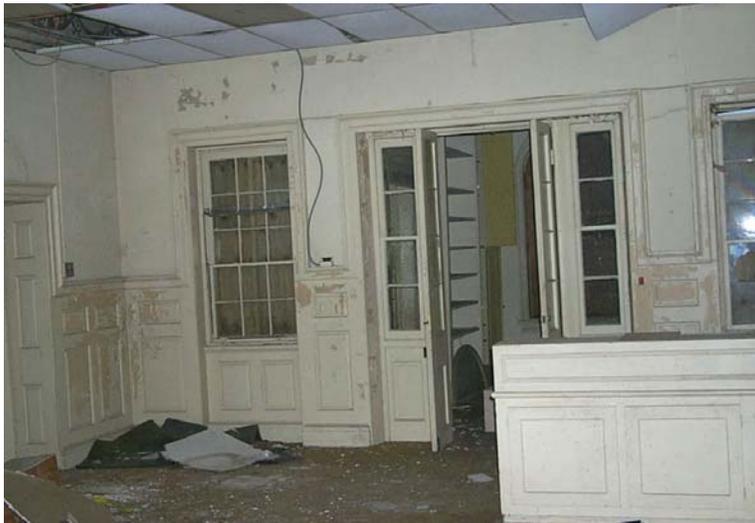
Current Condition - Interior

The interior wooden structure and plaster/paint finishes have been severely damaged since the building was abandoned in 1988. There are many areas that are unsafe to walk and there remain high levels of mildew and mold on many of the materials. The interior can be successfully rehabilitated, but the costs will be high.

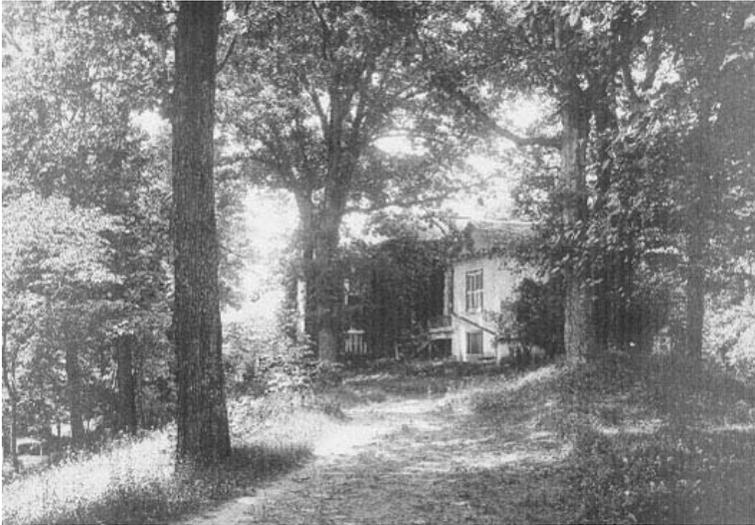
Summer 1889 – Approach from Adams Mill Road

This approach remains relatively the same today. The notable exception, however, is that the dirt and grass path and surrounding landscaping have been replaced with pavement, leaving a small island of grass and landscaping around the house.

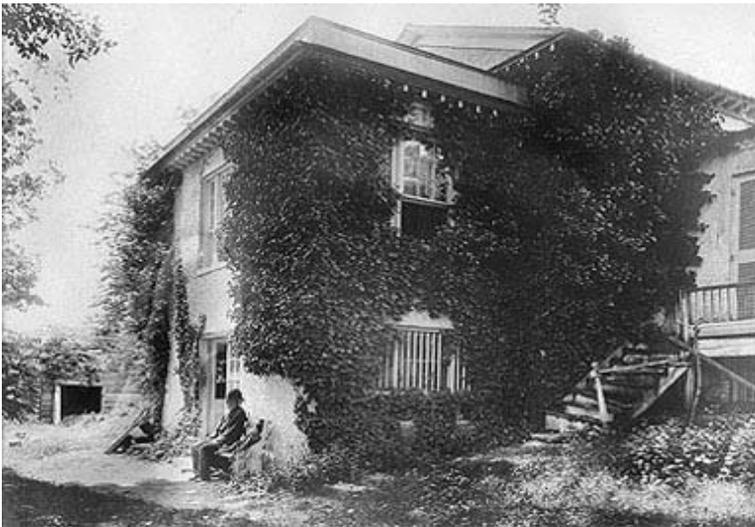
Summer 1889 – South Entrance

Notice the ivy engulfing the house and climbing in through the window. Ivy, if left unrestrained, can cause extensive damage to brick masonry by tearing away the mortar joints. Also, note the collapsing staircase to the right of the photo. The house shows a general sign of neglect at the time the Zoo purchased the property.

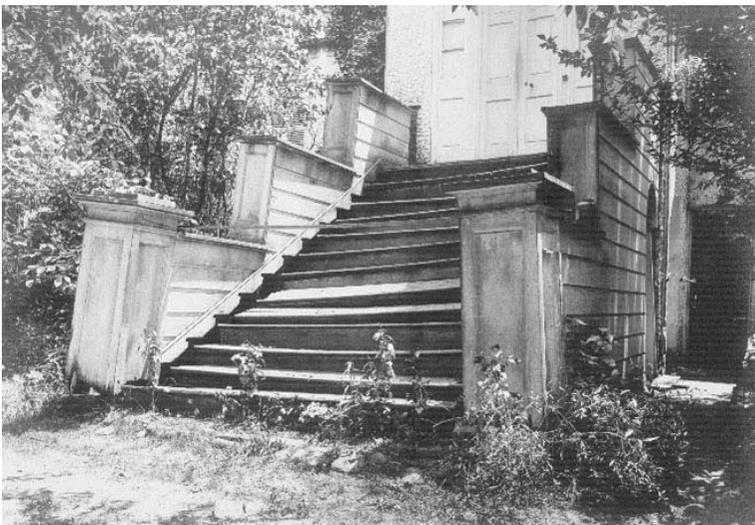
Summer 1889 – North Steps

These steps were removed shortly after the Zoo took control of the property. A few years later the Zoo constructed a cantilevered addition at this location. Again, note the general disrepair of the house.

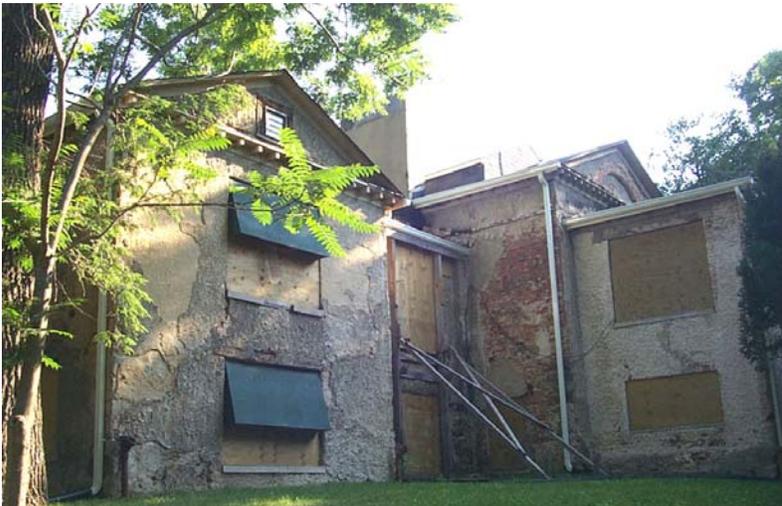
View from Southwest

The green awnings above the windows are vents to allow air flow through the house. This circulation allows the interior to remain relatively dry. All windows have been boarded up, keeping the interior dry and free of rodents. Note the bracing against the wall of the hyphen. This bracing protects against horizontal deflection and aims to keep the walls standing.

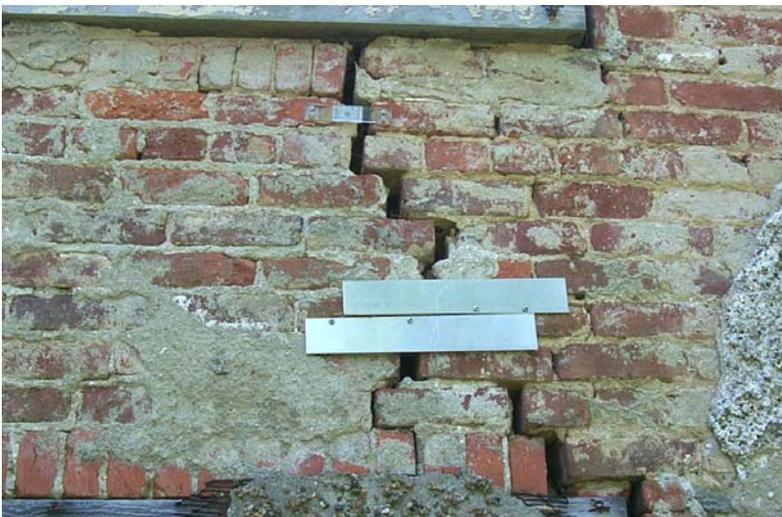
Typical Masonry Crack

This crack and glass monitor is typical of several locations around the house. Cracks approximately 1" in width have opened up at the corners of the structure and run from ground to the second floor. A structural report prepared in 2000 stated that the building is not actively moving and only 1mm of movement was recorded. This movement could be attributed to errors in taking the readings.

In 1999, as a result of community pressure, the Zoo hired a structural consulting firm to monitor cracks and movement of the structure. Monitors were placed on the cracks, and the results were recorded over a seven-month period. After reviewing the results, it was determined that the maximum movement was less than 1mm and this could simply be attributed to errors in recording the measurements. (Cagley & Associates – Holt House Movement Monitoring) In short, the cracks did not appear to be actively moving. At the same time as the crack movement was being recorded, measurements were taken to determine whether the building as a whole was moving. Again these results indicated that the house appeared stable. Although the central volume of the building appeared to "grow" by 5/8", this was attributed to thermal expansion of the masonry during the summer months. (Cagley & Associates – Holt House Movement Monitoring)

Although the Cagley analysis stated that the building is not actively moving, its structural stability is still in question. The masonry and mortar joints are decaying at a constant rate and will continue to do so until re-pointed and a new coat of stucco has been applied. As of 1898, the foundations were sub-standard and probably did not even exist. The underpinning has certainly improved the condition, but sizes, composition, and depth of the foundation have not been verified for structural capacity. In addition to these exterior structural failings, the termite problem has not been proven to have been eliminated. Many of the floors on the interior of the structure have a "spongy" feeling. This could be due in part to rot caused by constant dampness or could be due to weakened joists caused by termite damage. Again, very little of the structural system of the building can be verified to be in good condition. A structural engineer should perform a complete evaluation of all foundation, masonry bearing

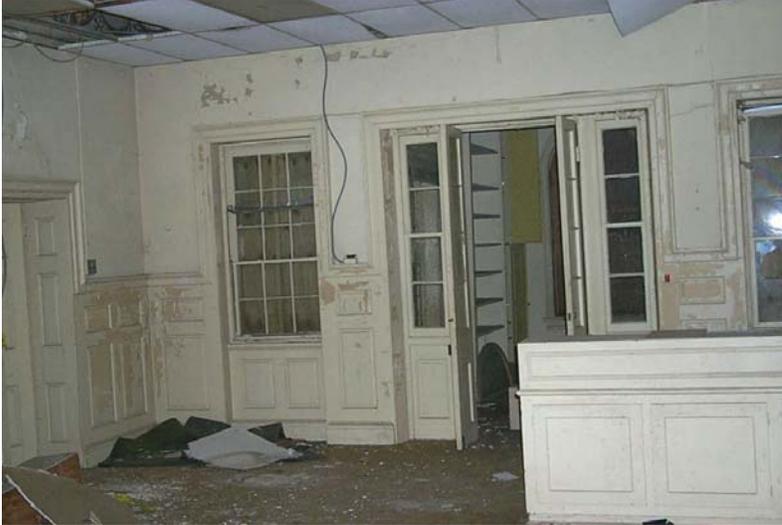
Second Floor Central Room

Much of the work in the second-story space dates to 1898-1899, based on proposals by architect Glenn Brown. His suggested improvements included enlarging the skylight and adding a decorative cornice. The lay-in ceiling shown in this photo dates to about 1973.

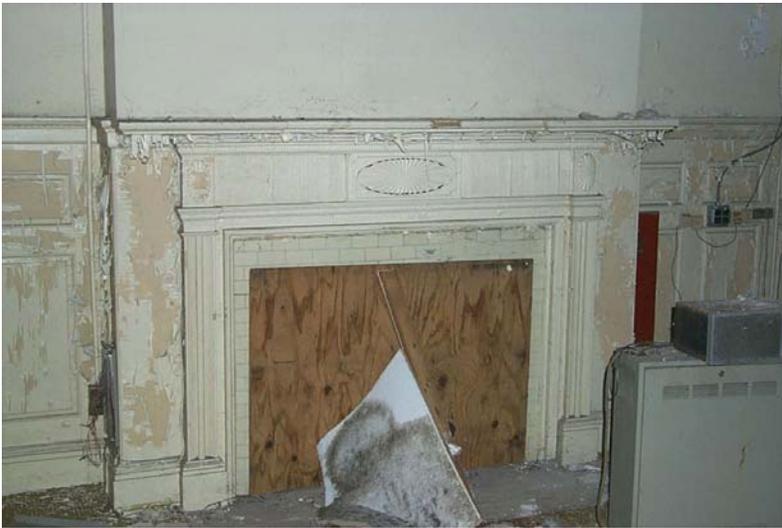
Fireplace in Second Floor Central Room

This fireplace was most likely done by architect Glenn Brown. Most of the interior work on the lower story of the house is attributable to the firm of Hornblower and Marshall.

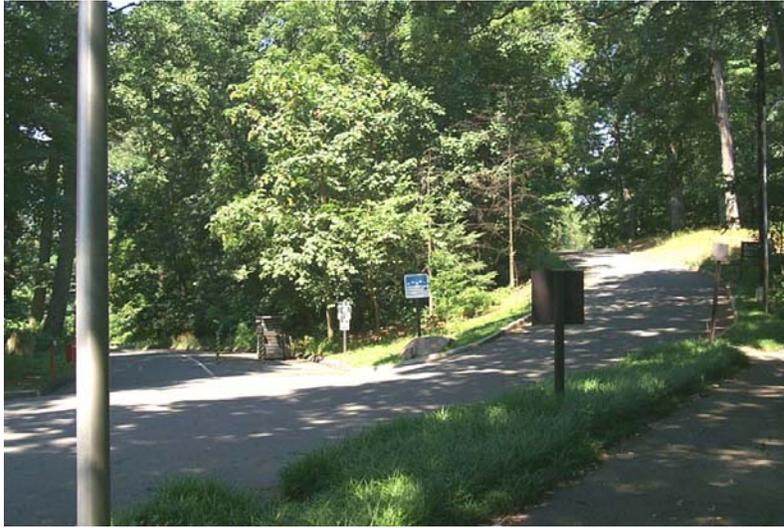
Entrance Path to Property Near Adams Mill Road

On the left is a maintenance road that is only accessible by Zoo personnel. On the right is another road that leads to Holt House and the animal research facilities and hospitals. One must travel down this road for approximately ¼ mile before reaching the house. The house is not visible from Adams Mill Road.

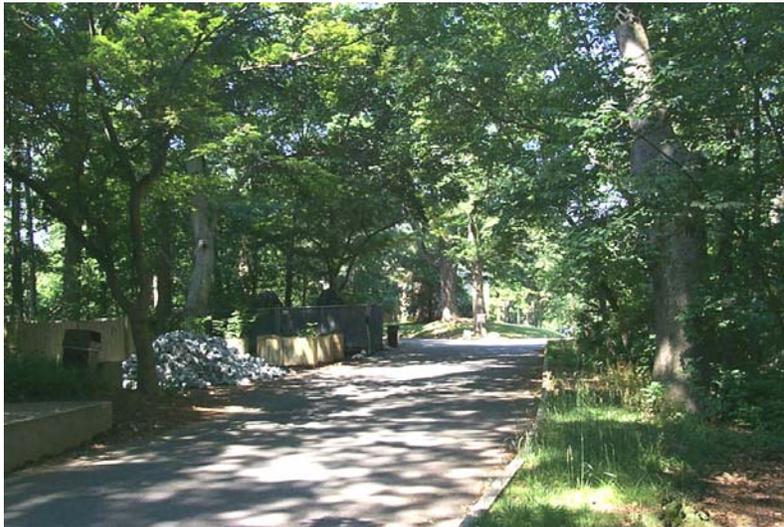
Service Road Approaching Holt House

The beginning of Holt House grounds can just be seen at the center of the photo. Note the collection of maintenance items on the left side of the photo. The Zoo uses this road as a storage facility for construction debris and waste. There is presently a large fenced-in area containing material for the renovated Connecticut Avenue entrance.

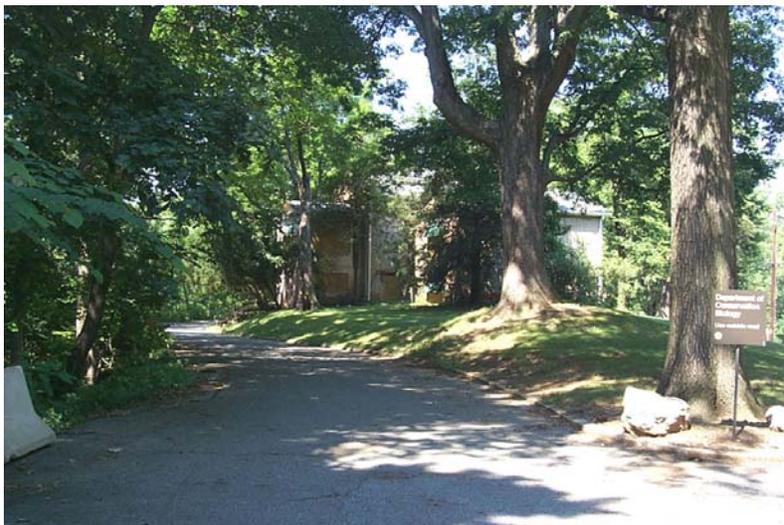
Holt House Property

Holt House is visible at the center of the photograph. Areas of pavement presently surround the house on all sides. Note the minimal yard area around the house.

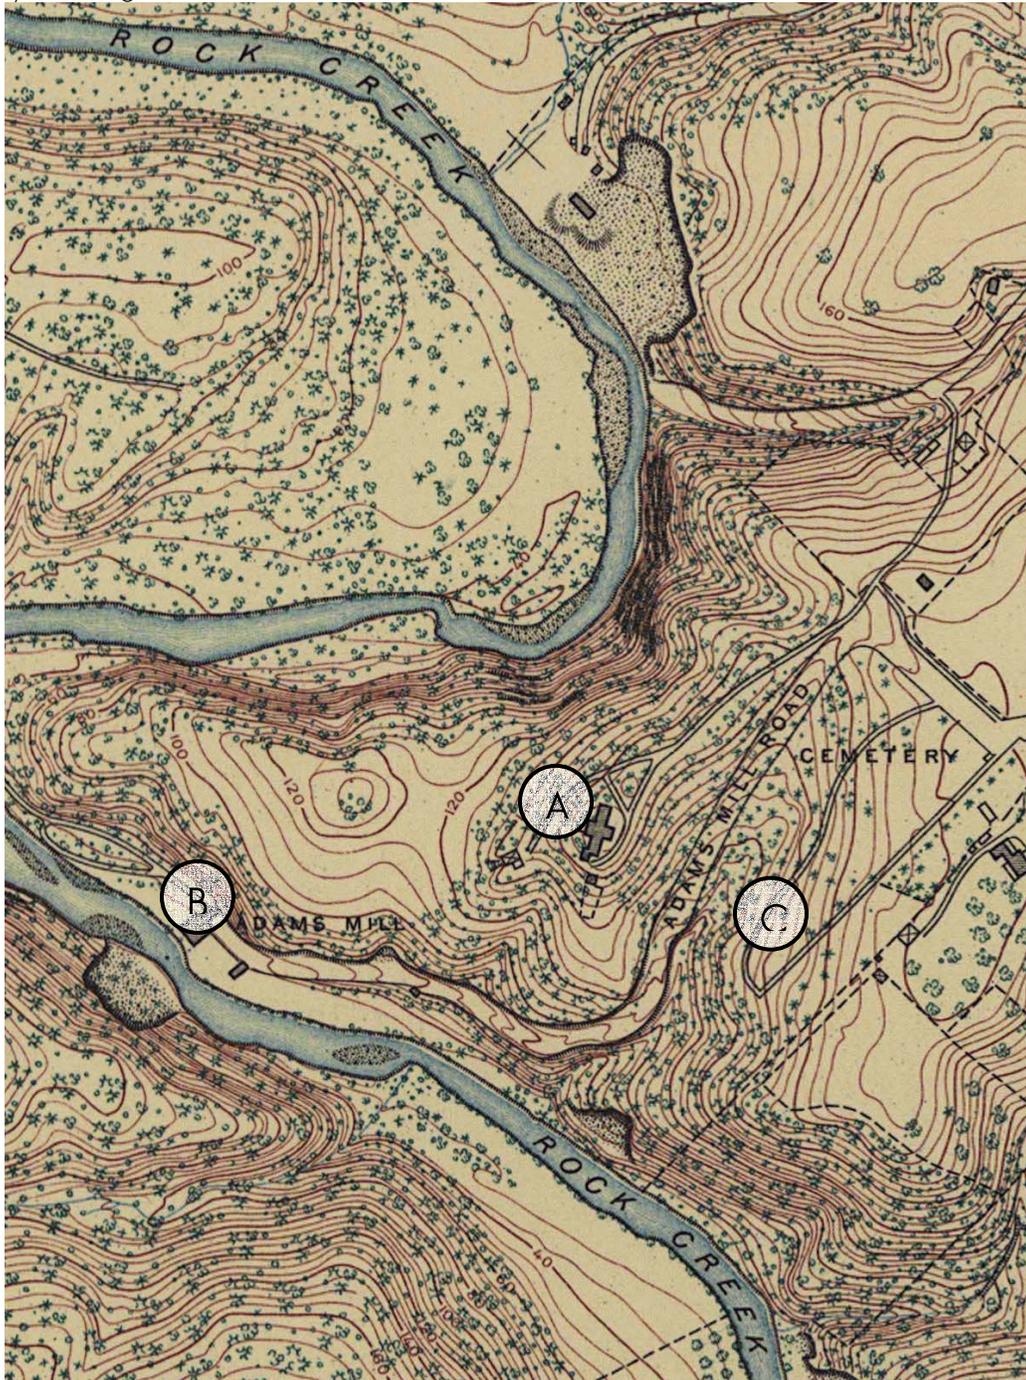
Historical Site Plan – Pre-Zoo Acquisition

Below is a map of the Holt House site as it stood before acquisition by the National Zoo in 1889. Holt House (A), Adams Mill (B), and The Colored Union Benevolent Association Cemetery (C) are all visible on this map, which was prepared by U.S. Coast and Geodetic Survey and engraved in 1892-94.
